**HISTORIC
SITES
SERVICE**

**SHELTER,
FEED,
AND DRAY**

A STRUCTURAL HISTORY
OF THE
RADWAY LIVERY BARN

**Occasional
Paper
No. 18
March 1989**

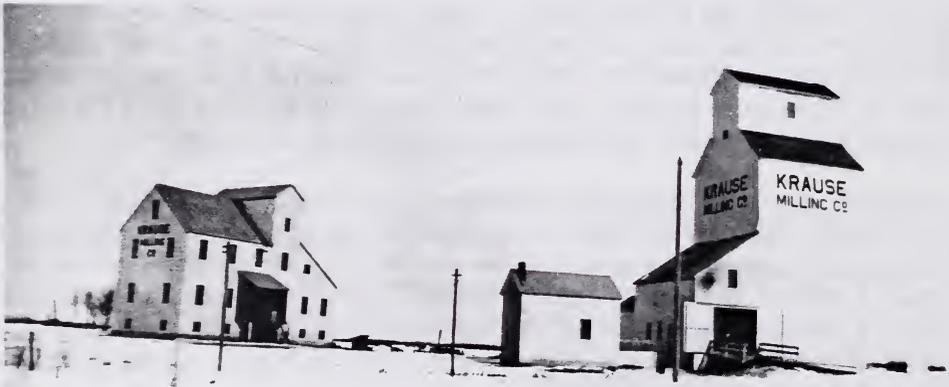
Figure 10. Krause Milling Company elevator and mill at Radway, Alberta circa 1937-1937.

nine per cent interest to help with the construction costs.³⁹ The mill was completed by 1929-30 (see Figure 10) and proved to be the apex of the town's rapid developmental boom, drawing in customers from a broad territory — customers who not only made use of the mill but who often spent money at the town's numerous other establishments.

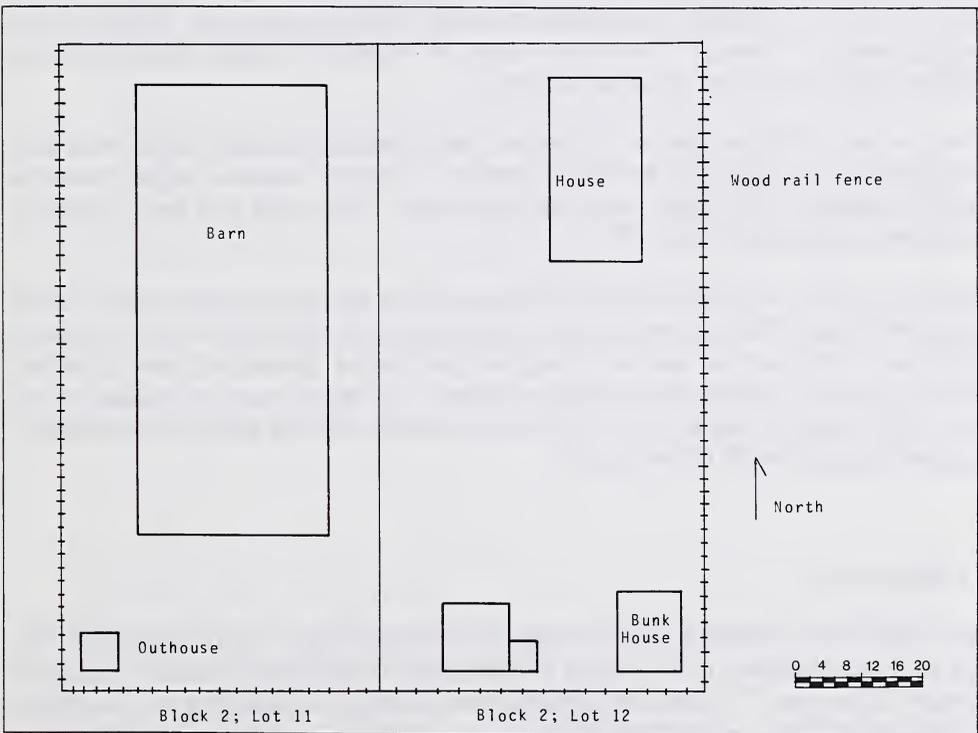
Figure 13. Radway Livery Barn yard plan circa 1929-1930.

In December of 1930, Tancowny acquired the adjoining lot (#12) to the east of his barn.⁶⁵ Tom had built a house on this lot, approximately 35 feet east of the barn on the northeast corner of the lot. This house was built soon after the barn was erected and measured approximately 14x28 feet. The house consisted of two rooms, had a shed roof dropping to the east, an enclosed porch to the west, and a main entry door facing the barn to the west as well. The north wall of the house was equilateral to that of the barn. Tom, and later his first wife, Haska, lived in this house along with hired-hand Jack Jacula (*Iatsula*). This was where they ate and carried on the business of the livery and dray. Occasionally friends were put up for the night in the house as well.⁶⁶

In the southeastern corner of the house lot Tom built a second smaller shack which was used as a bunkhouse for customers. This sleeping quarter measured about 10x12 feet, contained two beds and a heater, and had windows on its south and west walls. Card playing and drinking were activities not uncommon to this bunkhouse.⁶⁷

To the west of this sleeping shed and along the southern edge of the property, another somewhat larger shed with a partial lean-to was built. This shed has been described variously as a granary, a storage shed for wood and coal, an outhouse, a shoemaker's shed and someone's residence on the southern edge of the property.⁶⁸

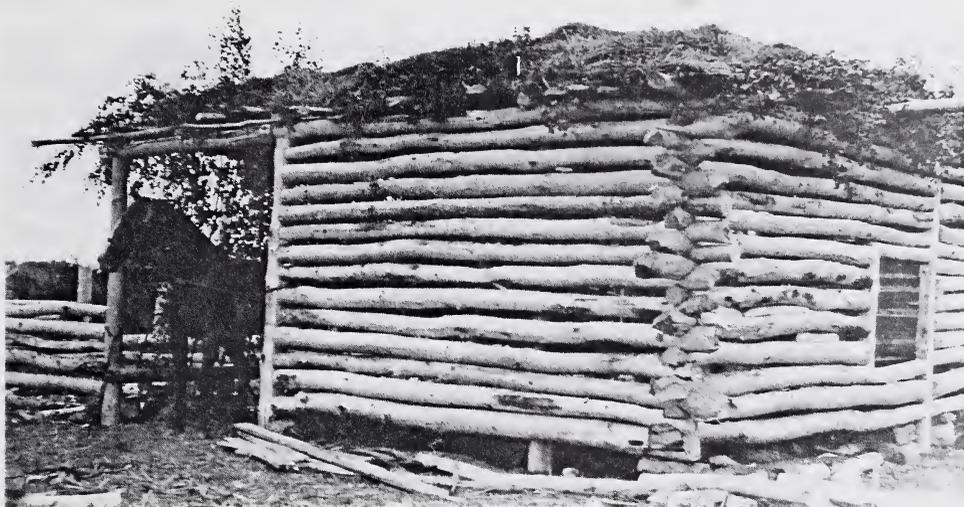
Figure 14. First horse barn on Petro Nahnybida's farm at Northern Valley, Alberta, 1926.

The free-standing all-purpose storage and animal shelters (*shopa*) of Western Ukraine were replicated by Ukrainian homesteaders in Alberta sometimes initially functioning as human shelters before fulfilling their intended function as animal stables. The long house variant of joint living quarters and stable accommodations were also constructed, but the nature and scale of farming in east central Alberta combined with the rapid expansion of Ukrainian farmsteads meant that the utility of such structures was quickly outgrown in favour of large-scale livestock barns (see Figures 14 to 17).¹⁸

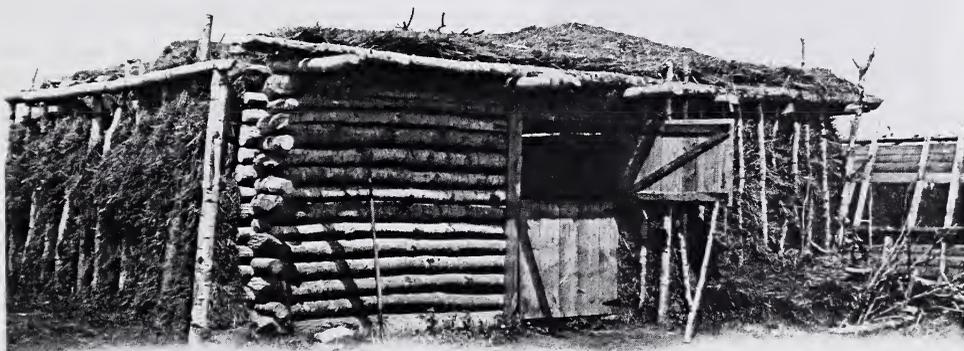
Figure 15. First horse barn on Petro Nahnybida's farm at Northern Valley, Alberta, 1926.

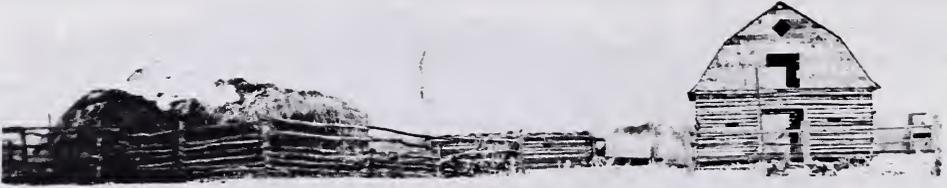
Figure 16. Toronchuk farmstead of Skaro, Alberta with large livestock barn under construction, December 22, 1920.

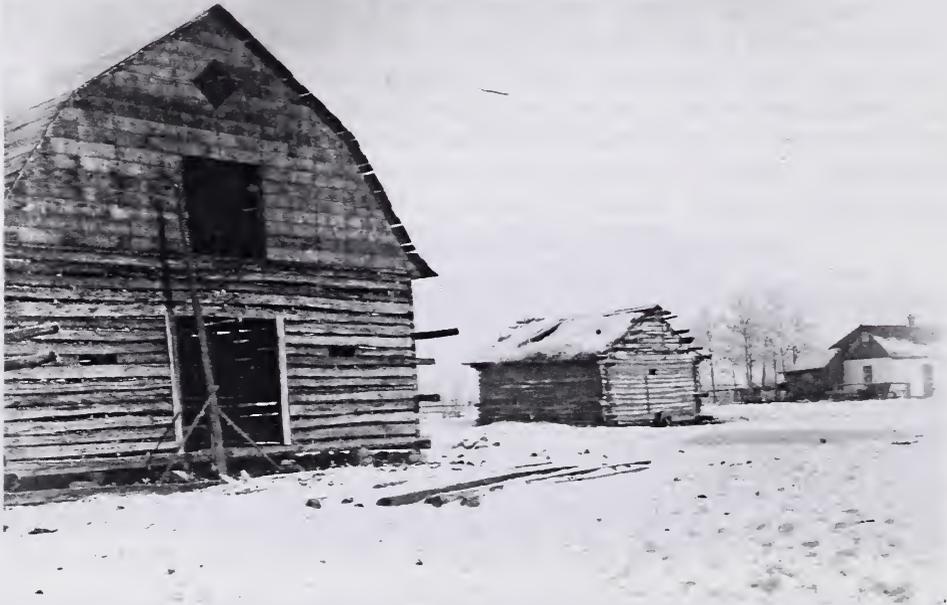
Figure 17. Toronchuk farmstead at Skaro, Alberta with large livestock barn under construction, December 22, 1920.

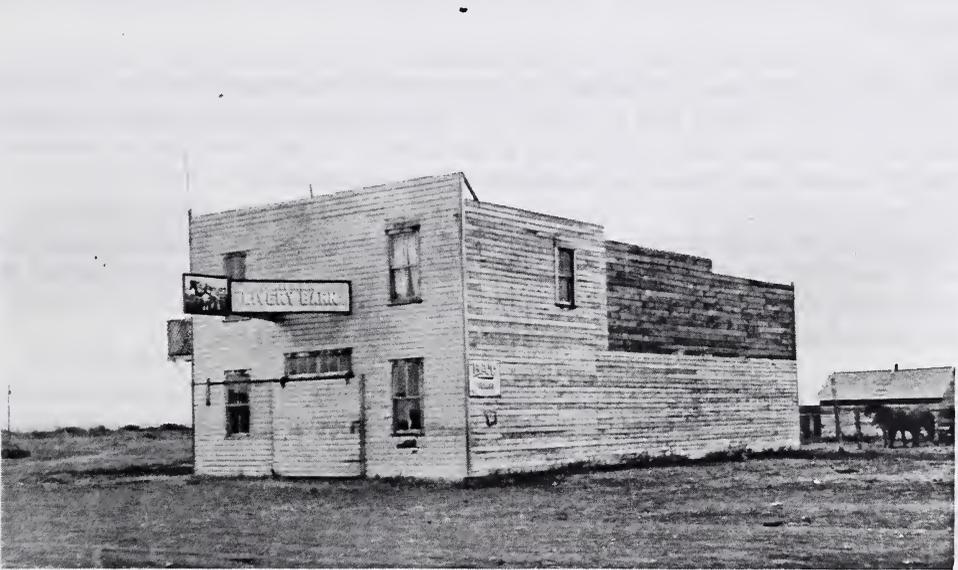
Figure 18. Stashyn Livery Barn at Chipman, Alberta.

buildings whose original function was far removed from that of boarding horses (see Figure 18).³²

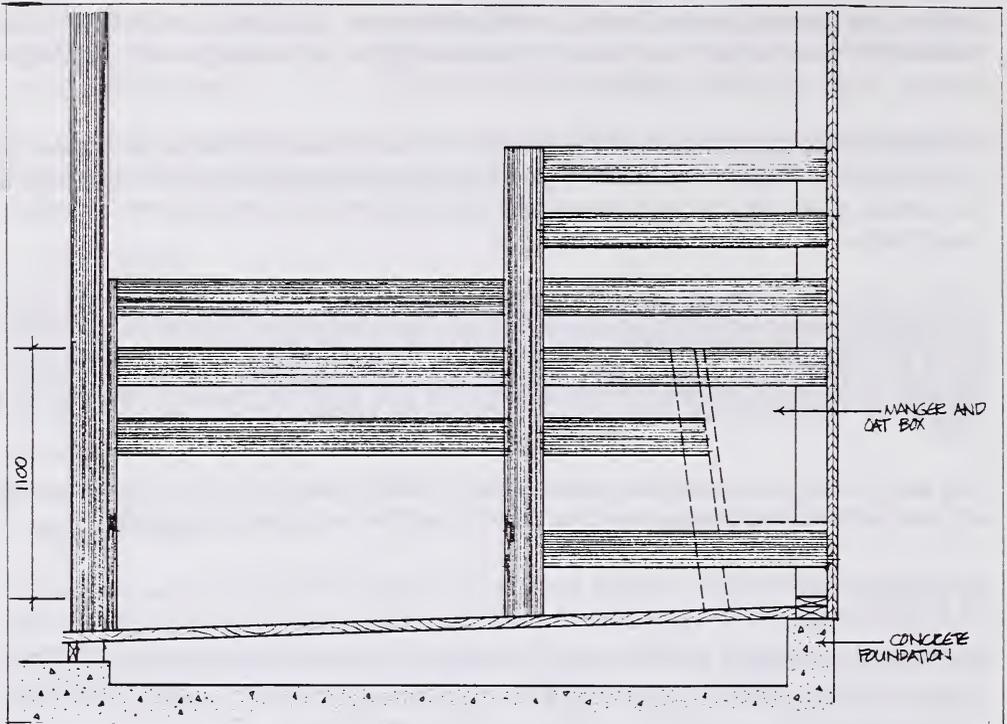
Figure 19. Radway Livery Barn - typical stall partition.

On the inside of both ends of each manger were two oat boxes measuring eight inches wide, 20-22 inches long and eight inches deep. They were constructed of one or two inch boards, were nailed into position, and rose six inches beyond the top of the manger. The holding capacity of these boxes was between one and two gallons of grain.⁶⁶

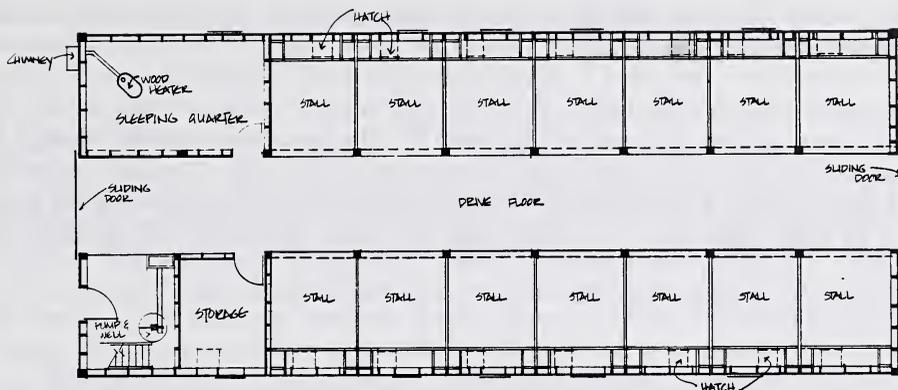
Figure 20. Radway Livery Barn - floor plan circa 1929-1930.

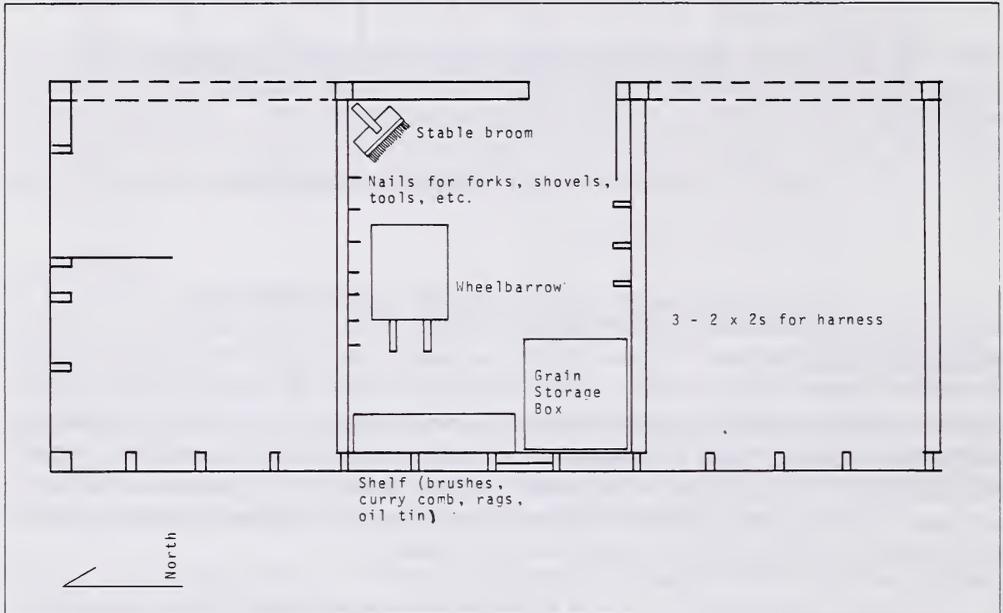
Figure 21. Radway Livery Barn - storage room plan.

The feed room had an exterior two by five inch stud frame on which an interior shiplap board finish was applied up to the ceiling joists.⁸⁹ The room was accessed through a homemade shiplap door on the south edge of the room's eastern wall. The door measured approximately two and a half by seven or eight feet and swung into the room on strap hinges on its south (left) side. To prevent theft this room was locked with a clasp and padlock.⁹⁰

The interior of the room was used for storing feed grain, various implements used in the barn, as well as the harness owned by the proprietor.⁹¹ Feed grain stored in the room was kept in a large wooden box which measured roughly three feet square. The box was not fixed into one given spot and, as a result, informants recall it being located in a variety of locations. The southwest corner is the most favoured location.⁹²

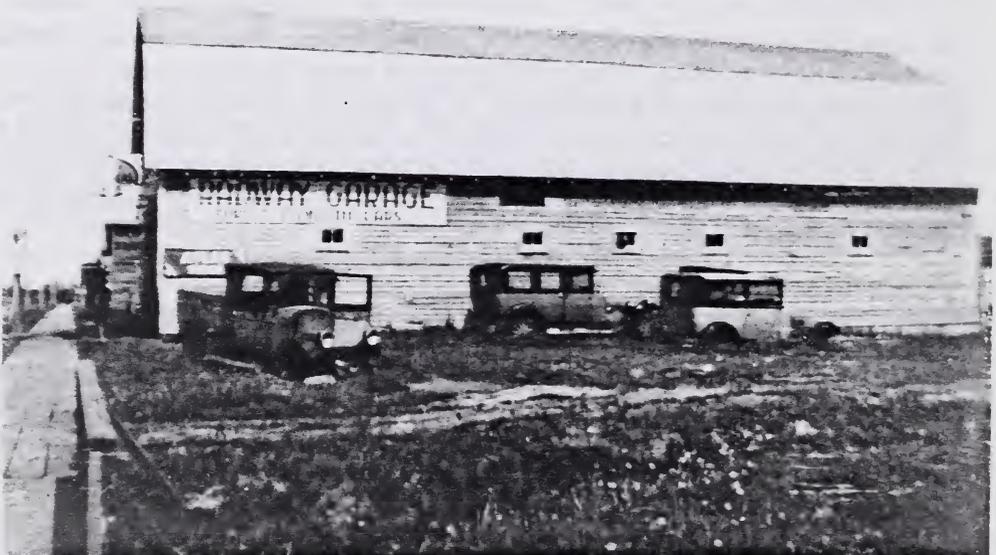
Figure 23. Radway Garage - west elevation circa 1938-1939.

In the upper corner of the wall's northern edge a 3.5x20 foot sign was painted advertising the Radway Garage (see Figure 23).¹²⁸
