SHELTER, FEED, AND DRAY

A STRUCTURAL HISTORY
OF THE
RADWAY LIVERY BARN

Occasional
Paper
No. 18
March 1989

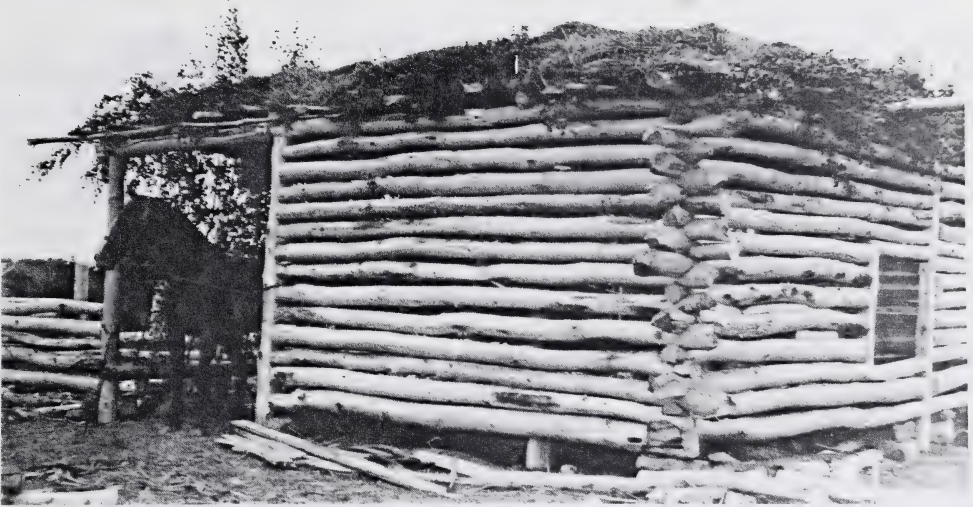
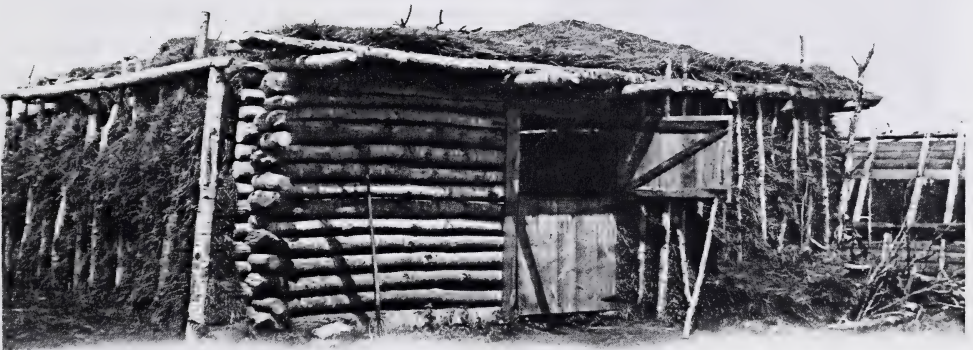
Figure 14. First horse barn on Petro Nahnybida's farm at Northern Valley, Alberta, 1926.

Figure 15. First horse barn on Petro Nahnybida's farm at Northern Valley, Alberta, 1926.

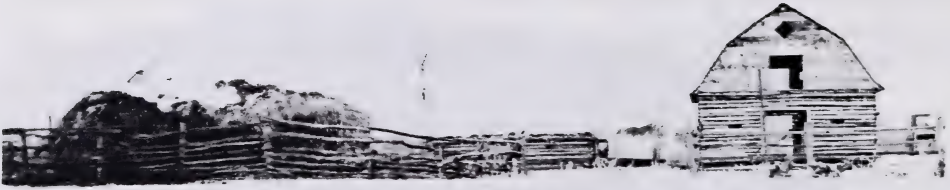
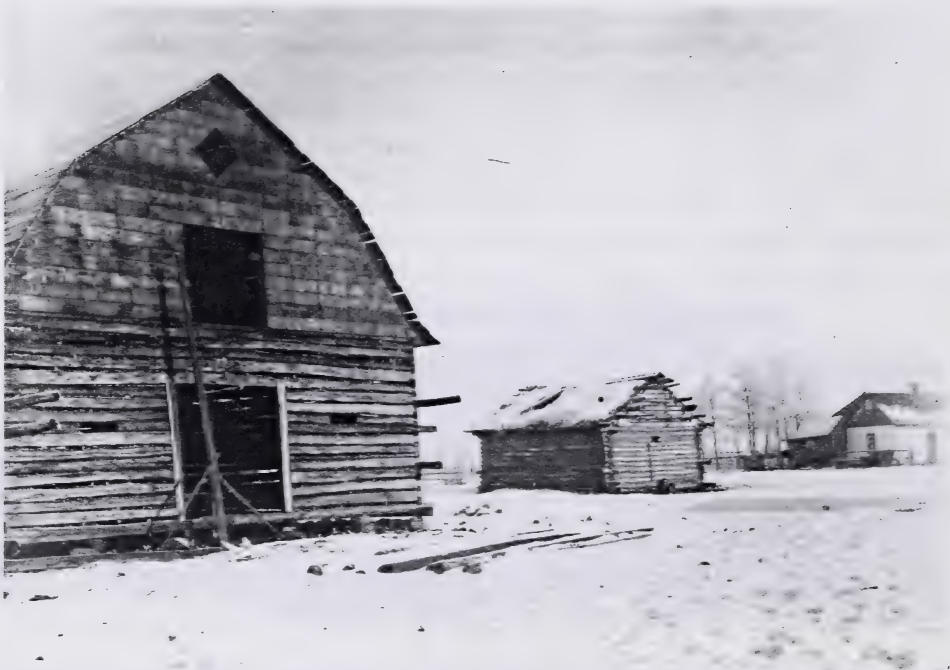
Figure 16. Toronchuk farmstead of Skaro, Alberta with large livestock barn under construction, December 22, 1920.

Figure 17. Toronchuk farmstead at Skaro, Alberta with large livestock barn under construction, December 22, 1920.
